# Manhole Inspection Summary

Manhole # S35MM1010MH

Insp Date: **3/13/07 11:00 AM**

**Location** Address: **4406 NORWOOD RD**

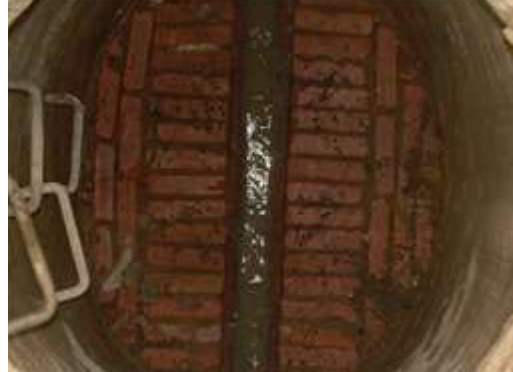
Top View

Bench debris.

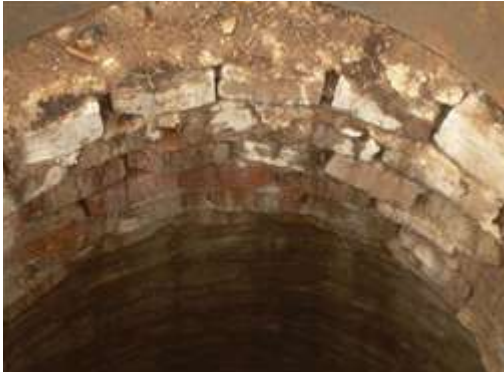
Defect

Frame leaks. Frame offset. Adjustment deterioration, loose brick and infiltration. Corbel and Barrel infiltration.

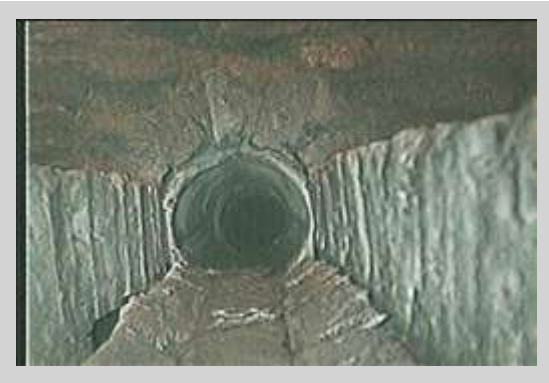
### 6 in. Circular Gravity Sewer Pipe Out @ 12 O'Clock

Barrel deterioration and infiltration. Channel deterioration.

Infiltration: **Evidence** Pipe Seal Cond: **Cracked**

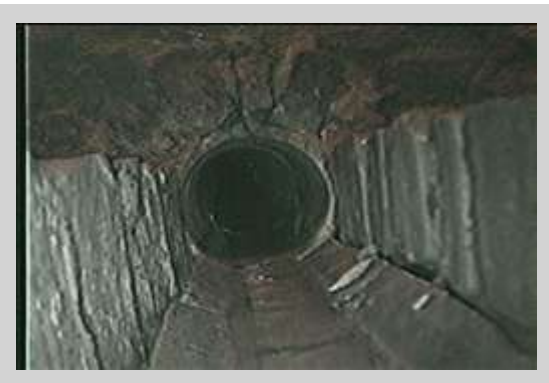
### 6 in. Circular Gravity Sewer Pipe In @ 6 O'Clock

Infiltration: **Evidence** Pipe Seal Cond: **Cracked**
